CLASSIFICATION CARCELLA CONTROL - U.S. OFFICIALS ONLY
	COTINGENCE AGENCY
	INFORMATION REPORT CD NO.
COUNTRY Albani	法衛 가는 사람이 있다. 그는 사람이 하는 사람들은 사람들이 가지 하면 하다 하는 사람들이 되었다.
이 모습을 통해 대통령 하게 해 시	DATE DISTR 35 Oct 300
Person	rana Airfield 2. Port of Durres 3. Soviet NO. OF PAGES 2
<u> </u>	
	NO. OF ENCLS.
	SUPPLEMENT TO REPORT NO.
THE MANUAL PROPERTY.	
This document contains theory of the united stated stated order united stated stated or its contains in any games gibited by Law. Reproduction	REATION APPROTING THE NATIONAL DEFENDER THE SEASONS OF THE REPUBLISHER ACT UP OF THAN SHIPSOND ON THE REPUBLIATION IT THAN SHIPSOND ON THE REPUBLIATION IT TO AN UNAUTHORISHED PERSON IS PRO- S OF THIS FOOM IS PERSON IS PRO-
	ONDINATE
Tirana Airfi

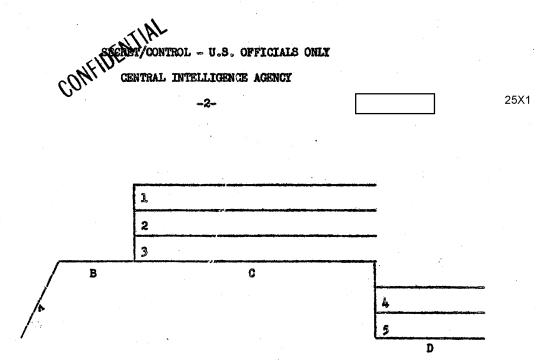
Barracks the fiel  2. Two prop in early four-mot  Port of Durr  3. Upon comp and port increase carried of  4. The prese a. The s  b. Secti concr  c. Secti	The concrete runway is barely visible through the high grass.  and offices are uninhabited. No work is in progress for restoring  d.  eller-driven fighter planes of Soviet manufacture were on the field July 1951.  proved planes. There is no evidence of the presence of jet aircraft.  es  pletion of the work now in progress for the improvement of the docks equipment, the capacity of the port of Durres should be greatly  d. At the present time, loading and unloading operations are  put by using equipment which belongs to the cargo ships.  ent state of the improvements is as follows (see page 2):  section of the breakwater marked "A" is in extremely bad condition.  on "B" is a massive breakwater composed of huge blocks of reinforced  on "C" is the dock means.

Barracks the fiel  2. Two prop in early four-mot  Port of Durr  3. Upon comp and port increase carried of  4. The prese a. The s b. Secti concr  c. Secti Secti	The concrete runway is barely visible through the high grass.  and offices are uninhabited. No work is in progress for restoring d.  eller-driven fighter planes of Soviet manufacture were on the field July 1951.  state that the field is unusable by ored planes. There is no evidence of the presence of jet aircraft.  es  pletion of the work now in progress for the improvement of the docks equipment, the capacity of the port of Durres should be greatly d. At the present time, loading and unloading operations are but by using equipment which belongs to the cargo ships.  ent state of the improvements is as follows (see page 2):  section of the breakwater marked "A" is in extremely bad condition.  on "B" is a massive breakwater composed of huge blocks of reinforced on "C" is the dock proper. Section 1 is a wide-paved vehicle road.

Barracka the fiel  2. Two prop in early four-mot  Port of Durr  3. Upon com and port increase carried of  4. The prese a. The s  b. Secti concr  c. Secti Secti which the t	The concrete runkey is barely visible through the high grass.  and offices are uninhabited. No work is in progress for restoring d.  eller-driven fighter planes of Soviet manufacture were on the field July 1951.  brighter planes of Soviet manufacture were on the field state that the field is unusable by the planes.  There is no evidence of the presence of jet aircraft.  es  pletion of the work now in progress for the improvement of the docks equipment, the capacity of the port of Durres should be greatly but by using equipment which belongs to the cargo ships.  ent state of the improvements is as follows (see page 2):  section of the breakwater marked "A" is in extremely bad condition.  on "B" is a massive breakwater composed of huge blocks of reinforced on "C" is the dock proper. Section 1 is a wide-paved vehicle road.  on 2, now under construction, is a heavily-ballasted stretch over racks of the mobile ov

Barracka the fiel  2. Two prop in early four-mot  Port of Durr  3. Upon com and port increase carried of  4. The prese a. The s  b. Secti concr  c. Secti Secti which the t railw  d. Secti	The concrete runkey is barely visible through the high grass.  and offices are uninhabited. No work is in progress for restoring  d.  eller-driven fighter planes of Soviet manufacture were on the field  July 1951.  state that the field is unusable by  ored planes.  There is no evidence of the presence of jet aircraft.  eg  pletion of the work now in progress for the improvement of the docks  equipment, the capacity of the port of Durres should be greatly  d. At the present time, loading and unloading operations are  but by using equipment which belongs to the cargo ships.  ent state of the improvements is as follows (see page 2);  esction of the breakwater marked "A" is in extremely bad condition.  on "B" is a massive breakwater composed of huge blocks of reinforced  on "C" is the dock proper. Section 1 is a wide-paved vehicle road.  on 2, now under construction, is a heavily-ballasted stretch over  will unit racks for two railwey lines. Section 3 is being repaired;  racks of the mobile cranes are being reinforced, as well as a third  on "B" is a second deleter this section.

Barracks the fiel  2. Two propin early four-mot  Port of Durr  3. Upon compand port increased carried of  4. The prese a. The section concre c. Section section which the trailw d. Section althor	The concrete runway is barely visible through the high grass.  and offices are uninhabited. No work is in progress for restoring d.  eller-driven fighter planes of Soviet manufacture were on the field July 1951.  There is no evidence of the presence of jet aircraft.  es  pletion of the work now in progress for the improvement of the docks equipment, the capacity of the port of Durres should be greatly it. At the present time, loading and unloading operations are but by using equipment which belongs to the cargo ships.  ent state of the improvements is as follows (see page 2):  section of the breakwater marked "A" is in extremely bad condition.  on "B" is a massive breakwater composed of huge blocks of reinforced on 2, now under construction, is a heavily-ballasted stretch over will run tracks for two railway lines. Section 3 is being repaired; and track which runs along this section.  on "D" is a second dock which has been almost completely renovated, and hork is still under way on section 4. About 30 workers and 2 or three-ton cranes were employed here in early July.  SECURITY WARRANCE.
